# ROOF INSPECTION / BID

*Written report from the visit · Photos from the roof · FERG-2026-001*

| Property | Residence, Sublette County, WY | Inspected by | Josh Ferguson |

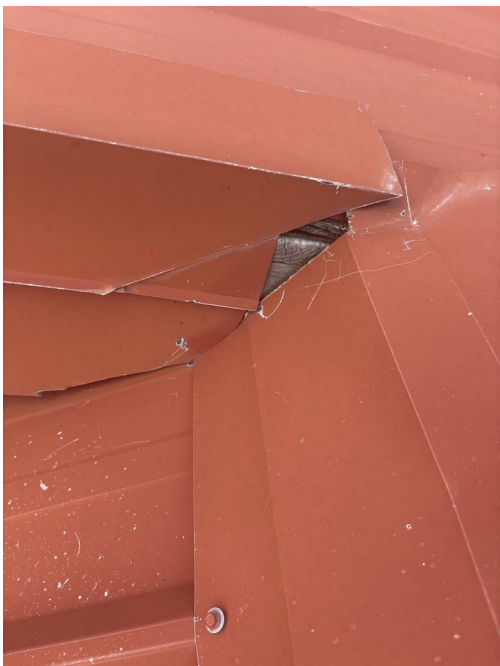
Where the metal meets the white wall, there is no step flashing and no wall trim. They ran the panel to the siding and left it. Photo 2. At the corner where the garage meets the house, the metal does not close. You can see wood in the hole. Photo 1. That will leak into the garage.

| | <p>Photo 1. The metal was cut short at the inside corner. There is a hole and you can see the wood. Water goes straight in. That is a leak path into the garage.</p> <p>Close that corner with metal flashing, fasten it, and seal it. Look at the garage ceiling and wall when we do it.</p> |

**1** Garage corner. Metal does not meet. Wood in the hole.

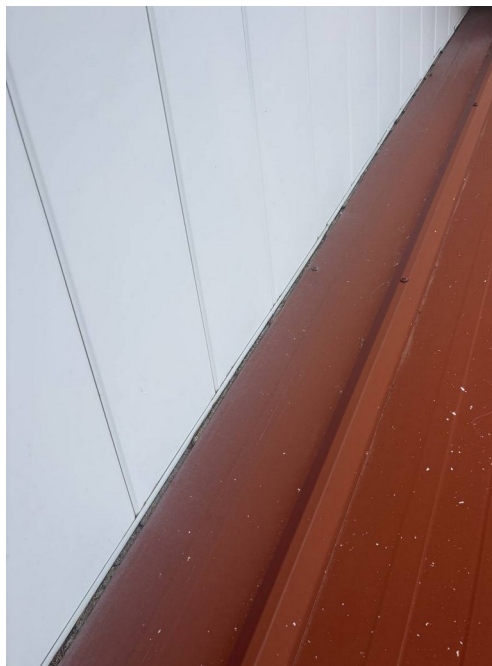
| | <p>Photo 2. The metal runs to the white siding and stops. No step flashing. No trim on the wall. They put this metal over the old shingles and counted on the old job to keep water out.</p> <p>Put proper sidewall flashing on so water kicks out onto the panel, not under it.</p> |

**2** Roof run to the white wall. No step flashing. No wall trim.

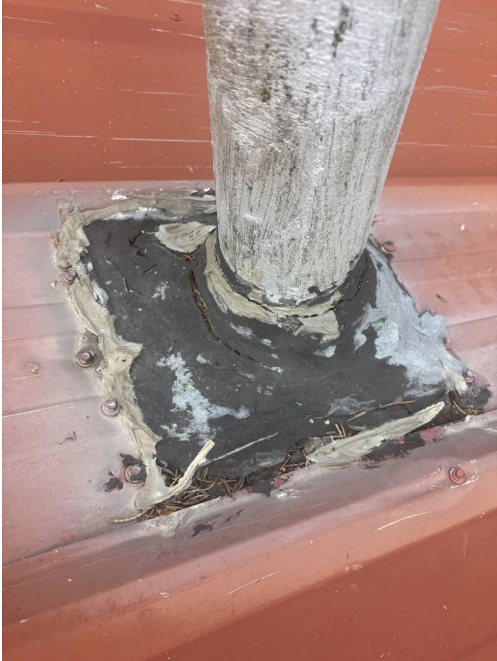
| | <p>Photo 3 is one vent. Asphalt sheet and mastic. Peeling. Needles under the edge. It does not follow the ribs. That is a shingle product on a metal roof. Two more vents are the same. No separate photo of vents 2 and 3.</p> <p>Pull the old boots. Put on three metal-roof boots that sit on the ribs. Fasten them and seal them. Do not just add more tar on what is there.</p> |

**3** One of three vents. Asphalt sheet and mastic. Peeling. Needles under the edge.

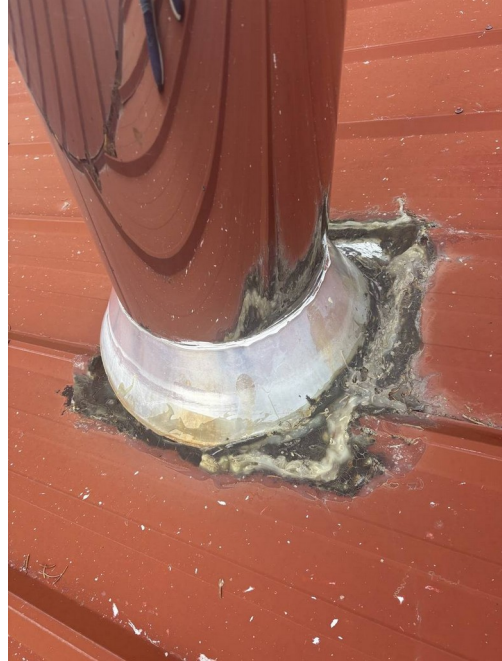
| | <p>Photo 4. Old mastic around the collar is cracked and pulled back. Even after we cap the pipe, this base will take water if we leave it.</p> <p>Scrape the old mastic. Reset or replace the jack and seal it right.</p> |

**4** Chimney jack. Old mastic cracked and pulled back.

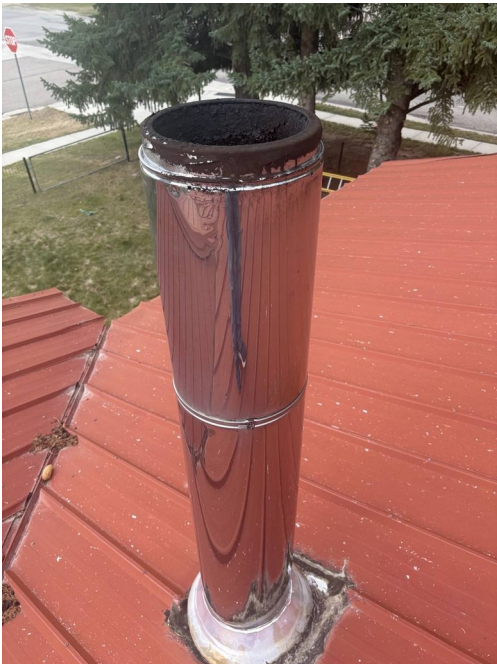
| | <p>Photo 14. Open flue. Thick soot on the rim. No cap. Matches soot coming down the chimney.</p> <p>Put a cap on it. Have the flue swept. The jack at the roof is a separate repair (photo 4).</p> |

**14** No cap. Soot on the rim.

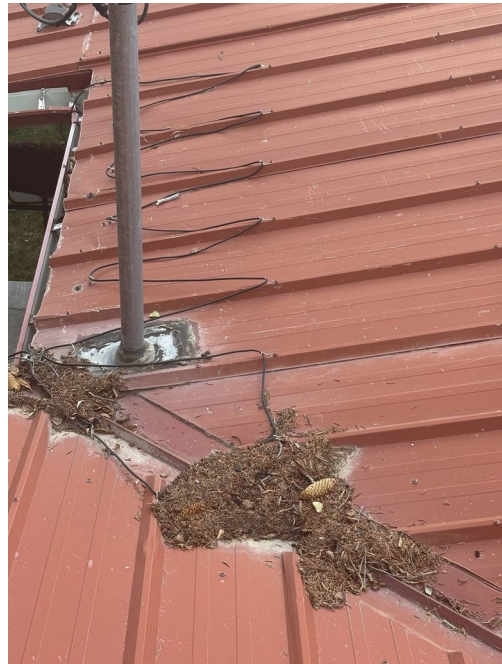
| | <p>Photo 15. A mast comes through a patched base. Cables are laid across the ribs and drop into the valley junk. Those wires hold needles and chew on the paint.</p> <p>Reflash the mast. Get the cables off the pans or clip them so they are not lying in the water.</p> |

**15** Mast through a patch. Cables across the ribs into a dirty valley.

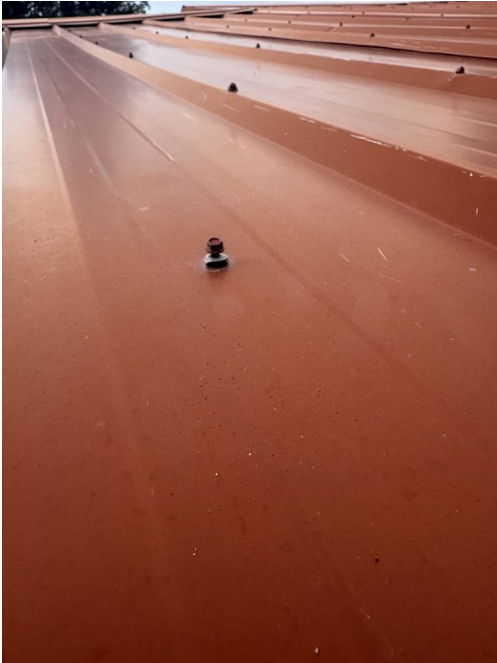
**5** Screw in the pan. This is how this panel is fastened.

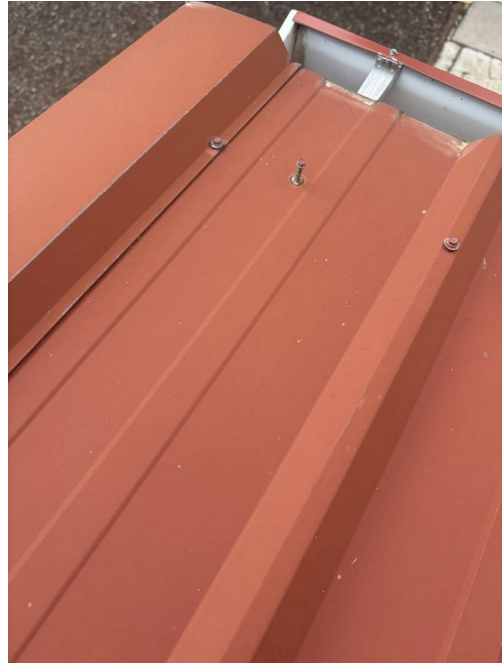
**6** Screw standing up near the eave. Threads showing. Washer not tight.

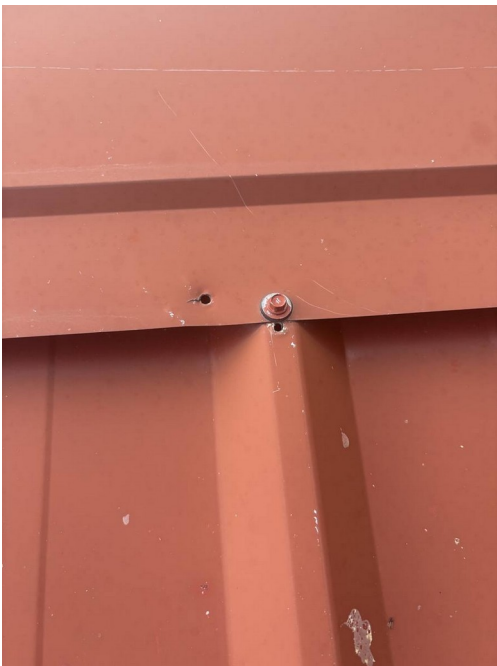
**7** Empty hole next to a screw, and another hole at the rib.

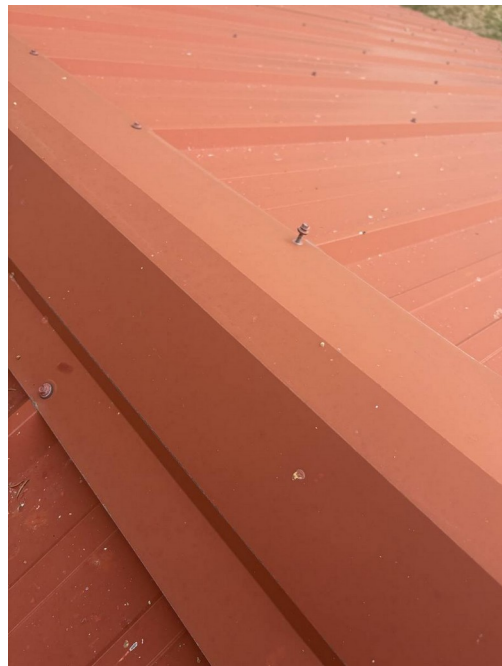
**8** Screw standing off the trim / ridge area.

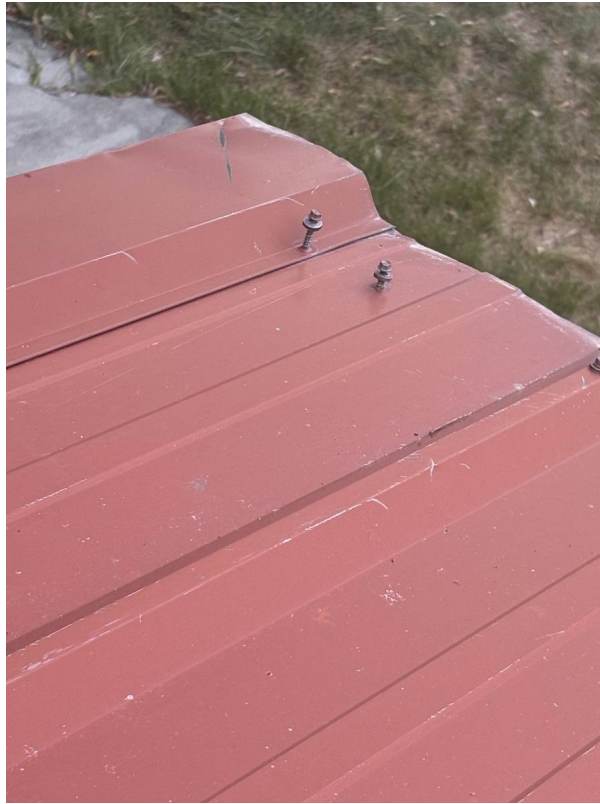
**9** Two screws standing up at the end of the trim. Trim is creased.

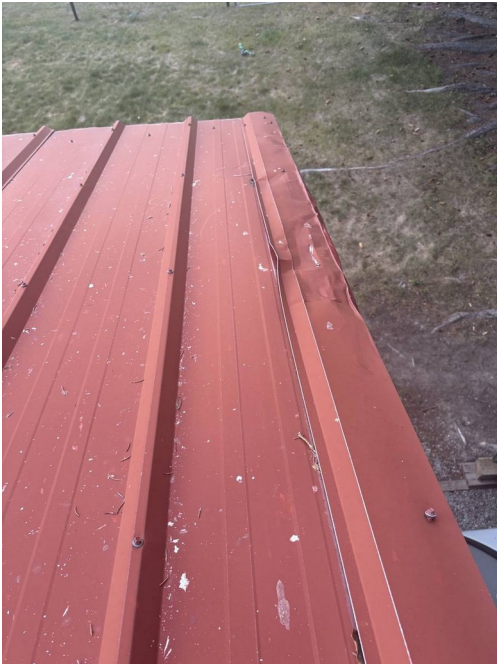
**10** Gap down the rake. Water can get behind the metal onto the fascia.

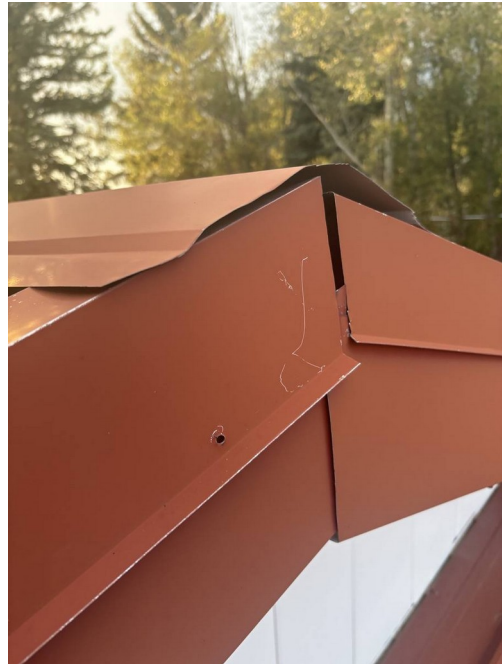
**11** Corner of the trim. Pieces do not meet. Empty screw hole.

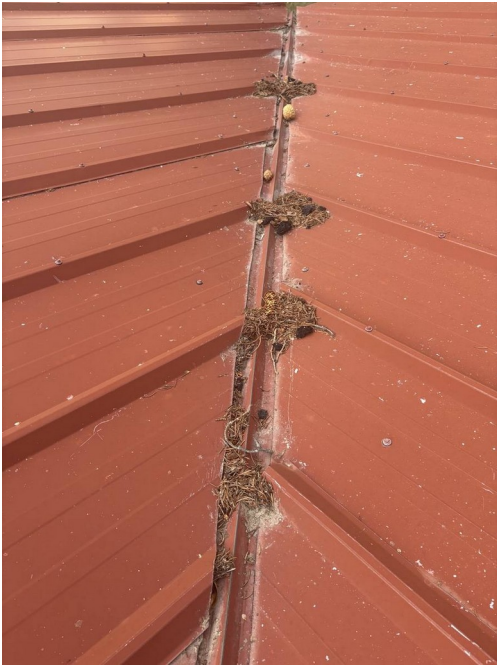
**12** Valley. Poor cut. Needles, cones, and sticks in the waterway.

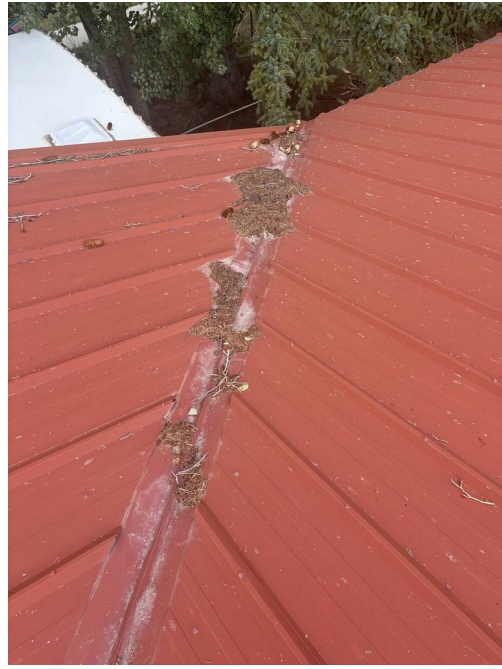
**13** Second valley. Same thing. Third valley not photographed.
